Project HORIZON-EURATOM-
2021-NRT-01-01

DELISA LTO

Description of the extended Lifetime and its influence on the
Safety operation and construction materials performance -
Long Term Operation with no compromises in the safety

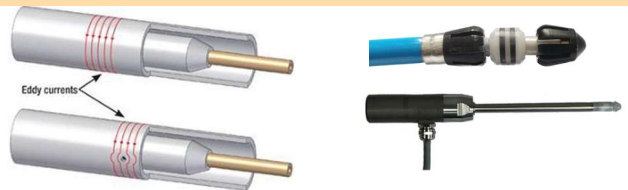
Fig. 1 Principle of ECT and typical Bobbin probe design and High speed Motorized Rotating Pancake Coil probe.

Work Package 2 of the DELISA-LTO project documents the operational experiences related to non-destructive testing (NDT) of heat-exchanging tubes in Slovakia, the Czech Republic, Ukraine, and Hungary. This WP also involves the experimental validation of Eddy Current Testing (ECT) techniques on a comprehensive matrix of steam generator samples, facilitating the transfer of application experience with these techniques to different countries operating WWER reactors.

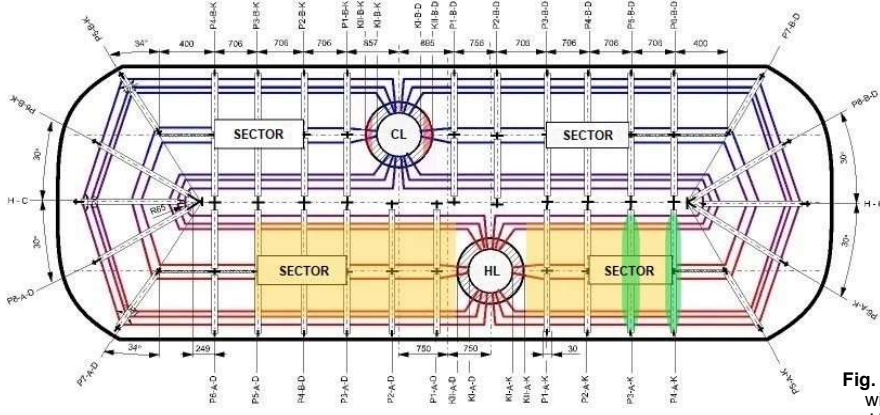
Fig. 2 Typical SG problem sections (NPP Slovakia).

The experience in Slovakia showed that common locations for the degradation of heat-exchanging tubes include the tube support plates and the tube-collector region (transition area). The prevalence of external defects and deposits has been primarily observed in the hot legs. Different ECT techniques and probes are used for inspecting steam generator tubes (SGTs). The SGT check is performed with a standard coil probe from VUJE, a.s. In-service inspection of the heat exchange tubes in the collector area is carried out with the MRPC (SOROTEC) probe from Tecnatom. One of the main criteria for plugging the tubes of the heat exchanger of the steam generator JE WWER-440 is when the indication detected by the bobbin probe exceeds 66% of the wall loss. The high-speed Motorized Rotating Pancake Coil technique was introduced in 2022 for in-service inspections of the heat exchange tubes in the collector area.

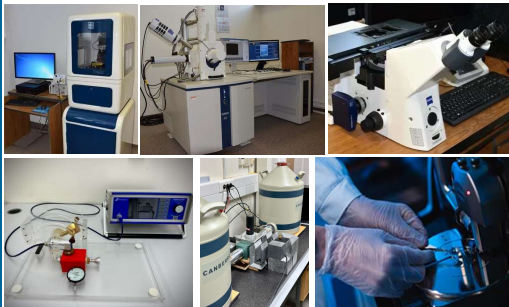
Fig. 11 Non-destructive techniques at STUBA.

The workshop will include presentation from experienced lectures from the practice and universities. The theoretical part will be supplemented by practical measurement with application of non-destructive techniques at Slovak University of Technology in Bratislava, Trnava and Jaslovske Bohunice, and with technical visits of NDT laboratories in VUJE and Slovenske elektrarne. The social program will include visit of SPA Piestany or other local cultural attractions.
